Avaya Solution & Interoperability Test Lab

Application Notes for Configuring Avaya Communication Server 1000E R7.5 with Visionutveckling Vision 80/20 Server V2.5 - Issue 1.0

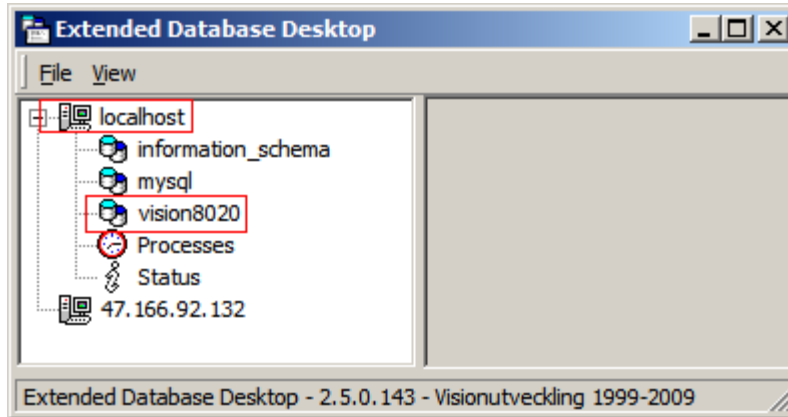
Navigate to `C:\Program Files (x86)\Visionutveckling\vision8020\tools` and run `edbd.exe` (not shown). After the `edbd.exe` is run, navigate to `localhost` and select `vision8020`.

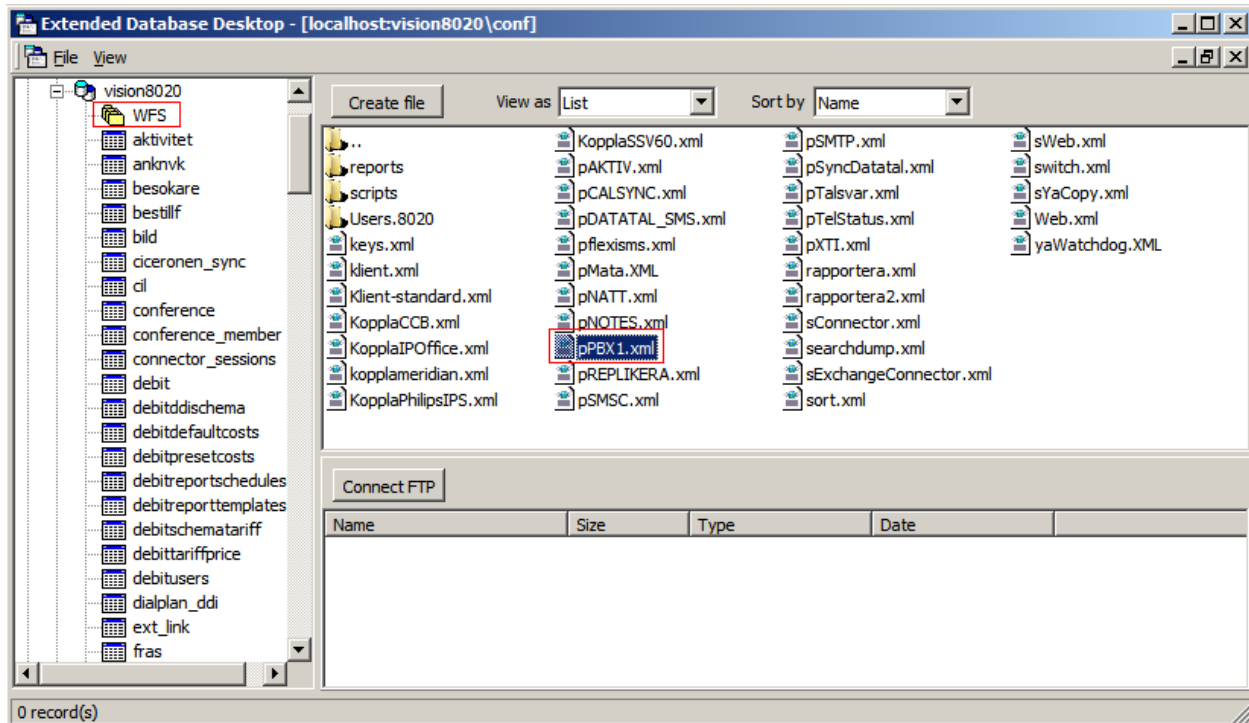
Double click `vision8020` and double click the folder `WFS`. A `conf` folder (not shown) will appear in the right hand window. Double click the `conf` folder and locate the `pPBX1.xml` file, and double click to open.
